Smoke and Dye Testing Summary

High Level Sewershed

Run Summary

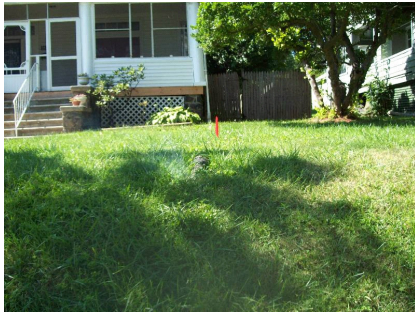
Picture \S1028-020-OB01-P01.jpg

Comments Smoke from cleanout in front yard. 3501 Fairview Ave.

Comments Front of house, 3501 Fairview Ave.

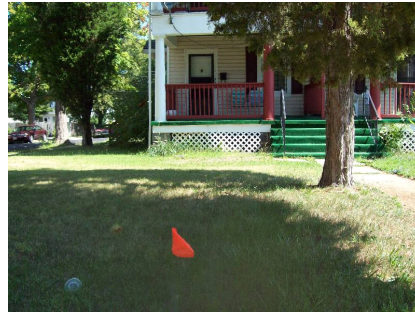
Picture \S1028-020-OB02-P01.jpg

Comments Smoke from cleanout in front yard. 3308 Fairview Ave.

Comments Front of house, 3308 Fairview Ave.
